CASE STUDIES:

PS 277 X

Building ID	X277
School Level	PS
Address	519 Street Ann's Avenue Bronx, NY 10455
Cross Streets	E 147 th & 148 th Streets
NYC DOE District	07
SHPO Status	Eligible
SHPO ID	02PR3147
Flood Zone	Zone 6
FEMA Map	3604970083F
Architect	C.B.J. Snyder
Year Built	1897
Plan Form	Type-A
Style	English-Flemish Renaissance Revival
Internal Sq Ft	88,750
Classrooms	50
Stories	5 + Cellar
Structural System	Composite Masonry/Frame
Columns	Cast Iron
Beams	Steel
Floors	Round Terracotta Vaults
Roof	Copper, BUR (2011)
Cladding	Brick, Limestone, Terracotta
Backup	Brick, Terracotta

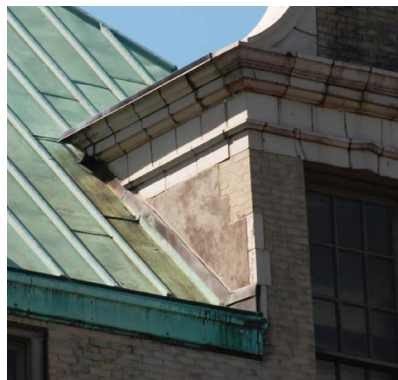
Fig. 6.1.5

Incomplete step flashing at the dormers, noted in a photographic survey, where thought to be a primary cause of water infiltration at fifth floor classrooms (see Fig 1.6). Courtesy: Nelligan White Architects

- Replace gutters and leaders around the mansard roof.
- Replace flashing at dormer returns and gable end walls.
- Provide for replacement of batten seam copper roofing as necessary to install flashing and gutters.

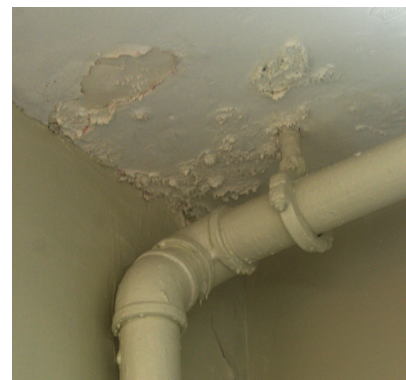
Fig. 6.1.6

Water damage in a fifth floor classroom at the interior of the dormers. Some damage had been cosmetically repaired, however constant water infiltration as a result of improper flashings causes continual damage. Courtesy: Nelligan White Architects

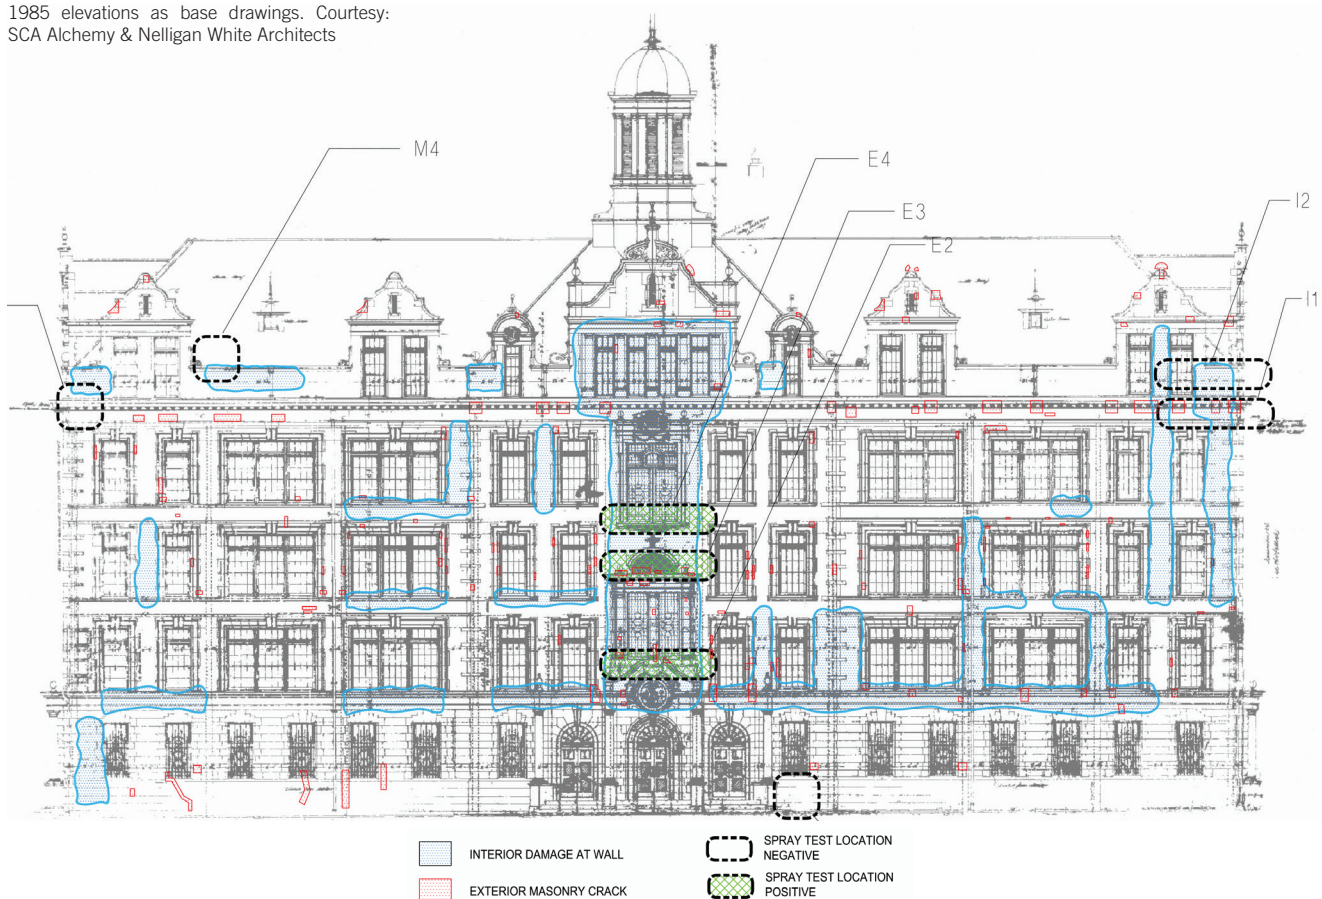
Fig. 6.1.7

Damage mapping diagrams using the original 1985 elevations as base drawings. Courtesy: SCA Alchemy & Nelligan White Architects

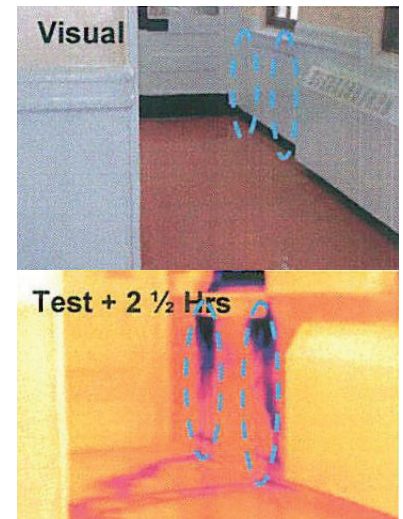
Fig. 6.1.8 (above)

Water damage visible below a window sill at the interior during a spray test. Infrared images note the differences in surface temperature, a strong indicator of moisture. Courtesy: GBG USA Inc.

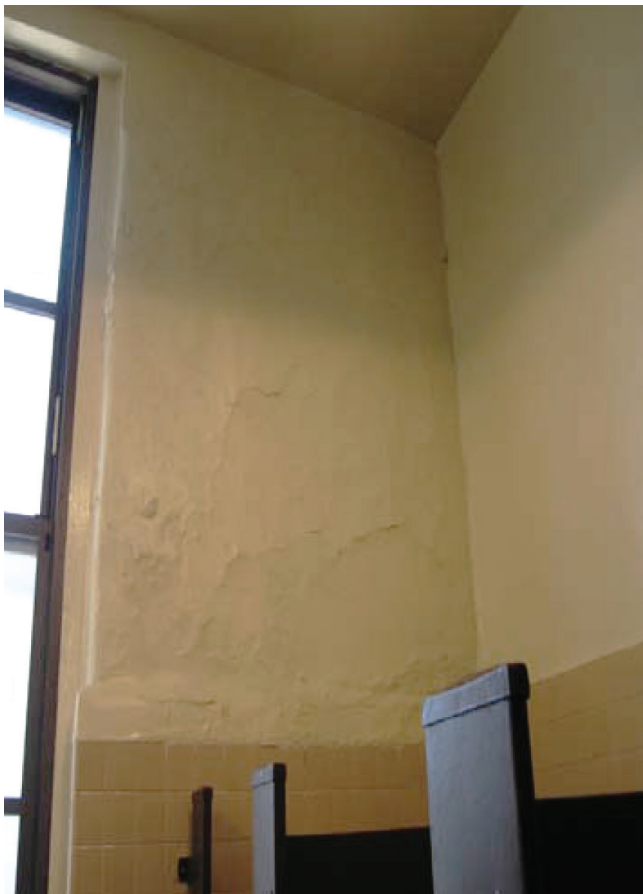
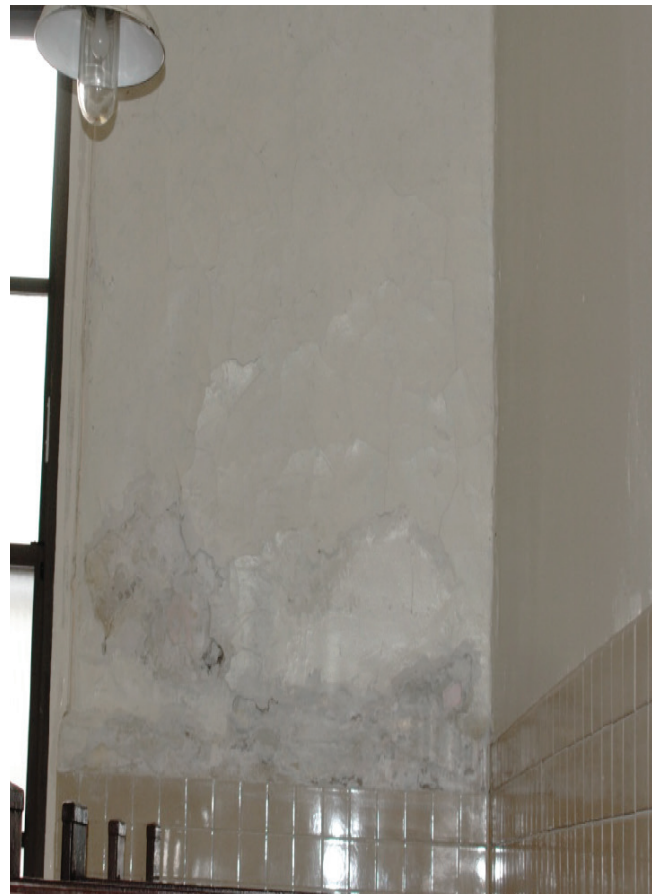
Two images taken at the same location approximately a year apart indicate quickly progressing damage. Courtesy: Nelligan White Architects

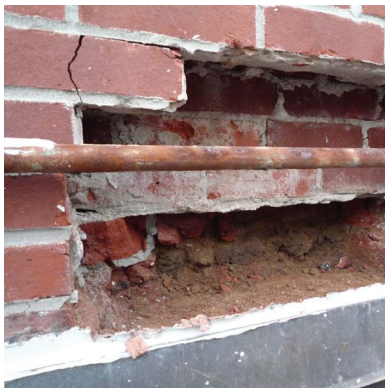
**Fig. 6.1.11**

Exploratory probes revealed backup masonry and mortar to be mostly in poor condition. Courtesy: Nelligan White Architects

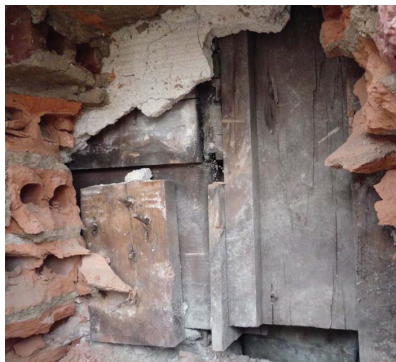
**Fig. 6.1.12**

Certain probes revealed wood blocking in locations where backup masonry should have been present. Courtesy: Nelligan White Architects

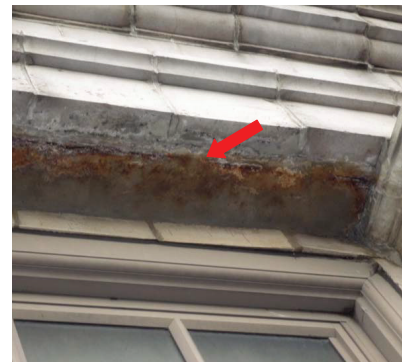
**Fig. 6.1.13**

Lintels at the window heads were found to be rusted. Courtesy: Nelligan White Architects

- Remove and replace all face brick on North, East, and South facades.
- Fill voids in the face of the masonry backup, point and parge.
- Spray, apply liquid membrane waterproofing, attach narrow cavity drainage plane and weeps.
- Install relieving angles at each floor spandrel.
- Remove and replace terracotta ornament at string courses, dormers, windows and entrances.
- Scrape, paint and flash existing iron/steel at all columns and spandrels exposed at exterior walls, provide steel repairs when necessary.
- Repair stucco at West façade, incorporate spray applied membrane waterproofing, 3" mineral wool insulation, drainage fabric and 3 coats stucco on furring channels and stainless steel lath with control joints.
- Replace sills and exposed lintels on west facade.

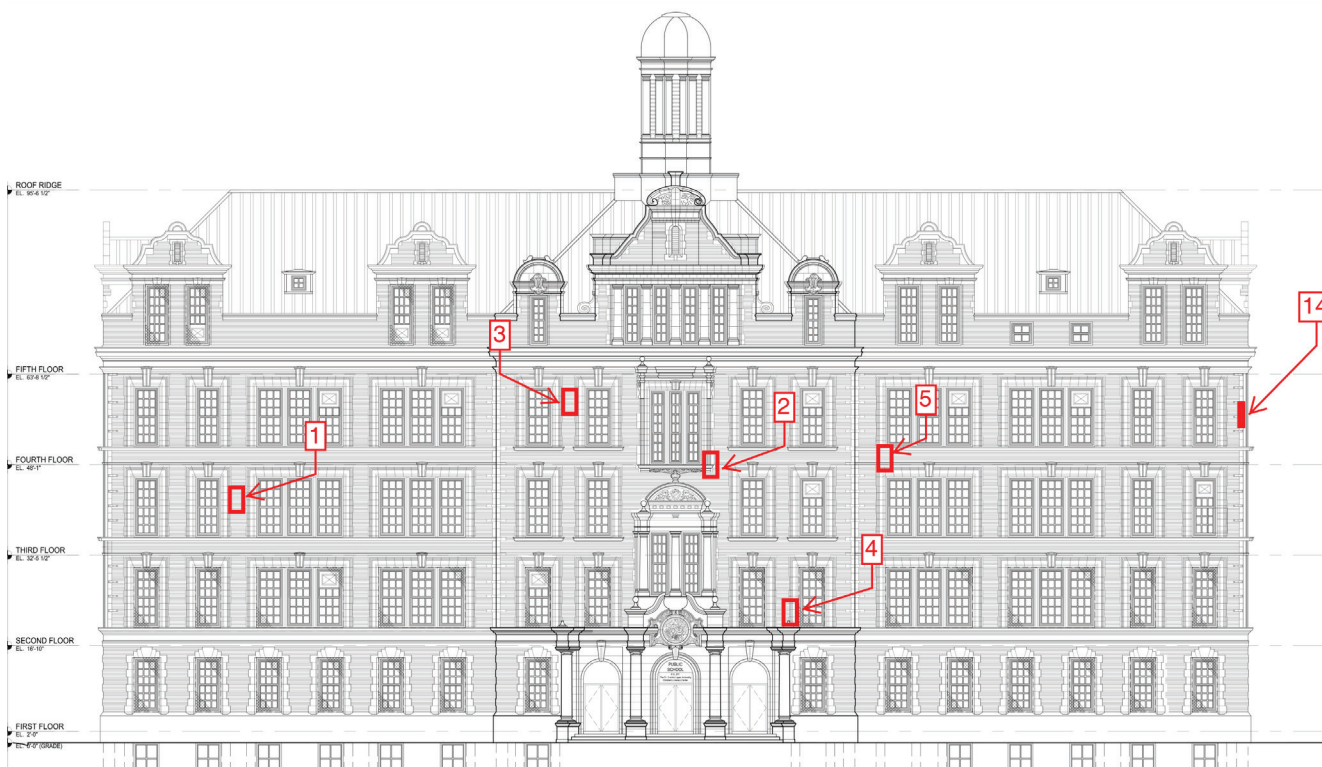
**Fig 6.1.14**

Probes were taken at selected locations in order to observe multiple conditions on the building. Courtesy: Nelligan White Architects

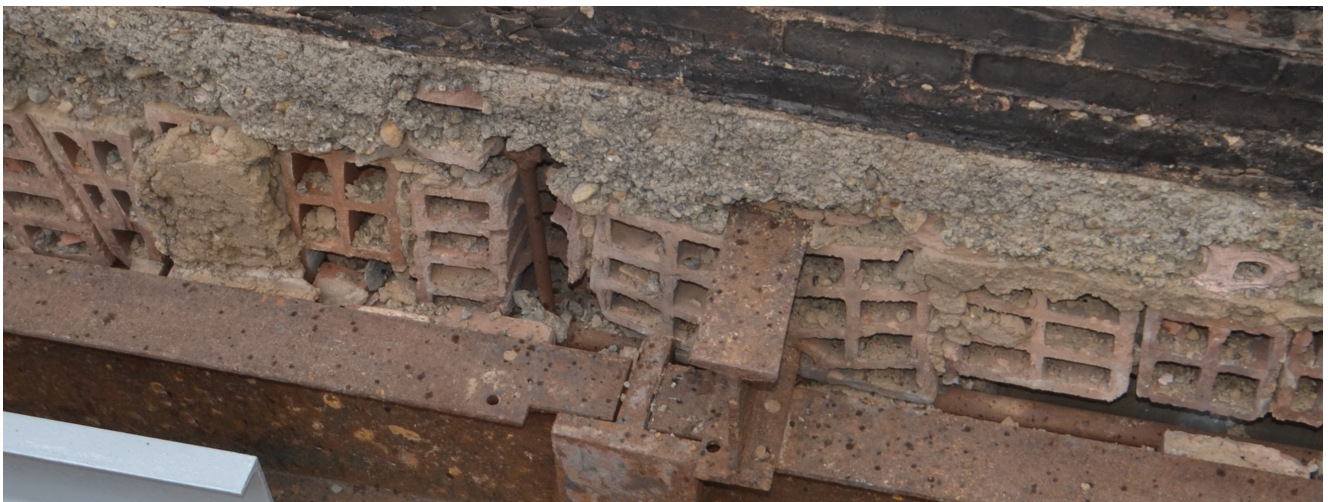
Testing of the face-brick and backup brick showed that both conformed to modern compressive and absorption standards. These tests indicated that it was not the masonry itself, but poor workmanship and hollow cores of the terracotta backup which provided conduits for moisture travel through the masonry. These deficiencies caused washout of the mortar and degradation of all masonry and steel elements as an effect.

Fig. 6.1.17 (far below)
Material testing pointed to washout of the mortar as a main cause of degradation, caused by holes in the terracotta backup. Courtesy: Nelligan White Architects

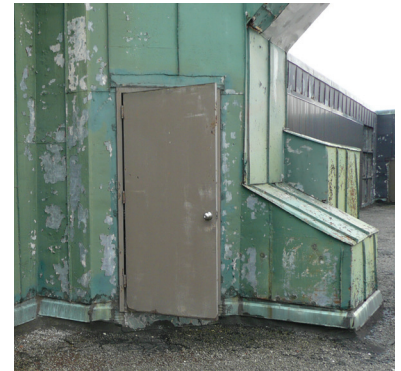
Fig. 6.1.20

Back side of the mansard roof before rehabilitation. Courtesy: Nelligan White Architects

- Remove all existing galvanized steel cladding & existing aluminum siding covering original light monitors.
- Removal galvanized cladding from back of mansards, existing light monitors, flashings and framing where damaged.

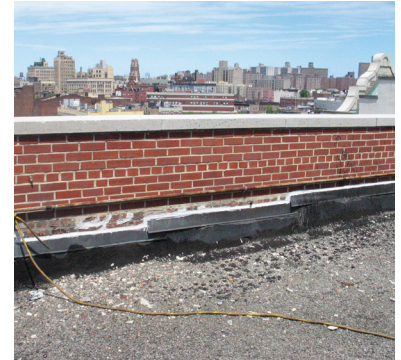
Fig. 6.1.27

Original design drawings, visual observations and probe investigations confirmed the absence of through-wall-flashing at the parapets. Probes along with the Assessment of Water Ingress Report confirmed that water passing through the back side of the parapet, was a significant source of damage at the top floor. These findings prompted the following recommendations:

Before rehabilitation, base flashing at parapet was not continuous. Courtesy: Nelligan White Architects

- Remove and replace existing masonry parapet with expansion joints, through-wall flashing, coping stones and scupper drains.

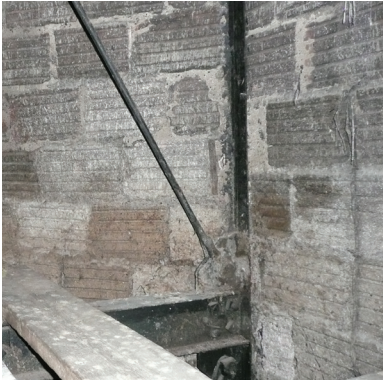
**Fig. 6.1.34**

Interior of the ventilation tower before cleaning. The ventilation system was abandoned decades prior, and nesting birds in the tower and shaft system contributed to concerns regarding poor/dangerous air quality. Courtesy: Nelligan White Architects

There presently exists no system for ventilation to classrooms and assembly spaces throughout the building, which stands as a code violation. It was observed that pigeons were nesting in the main duct risers, and had filled the ducts with large amounts of waste which posed a health hazard. While installing new mechanical ventilation systems was beyond the scope of this exterior rehabilitation, it was agreed that this project should address the breach in fire separation between the floors of the building created by the original exhaust ventilation shafts, which had open louvers at each floor. These findings prompted the following recommendations:

- Clean ventilation tower using industry and SCA accepted methods.
- Remove covers on existing register shaft openings.
- Provide new fusible link fire dampers and sheet metal covers at each exhaust register location.

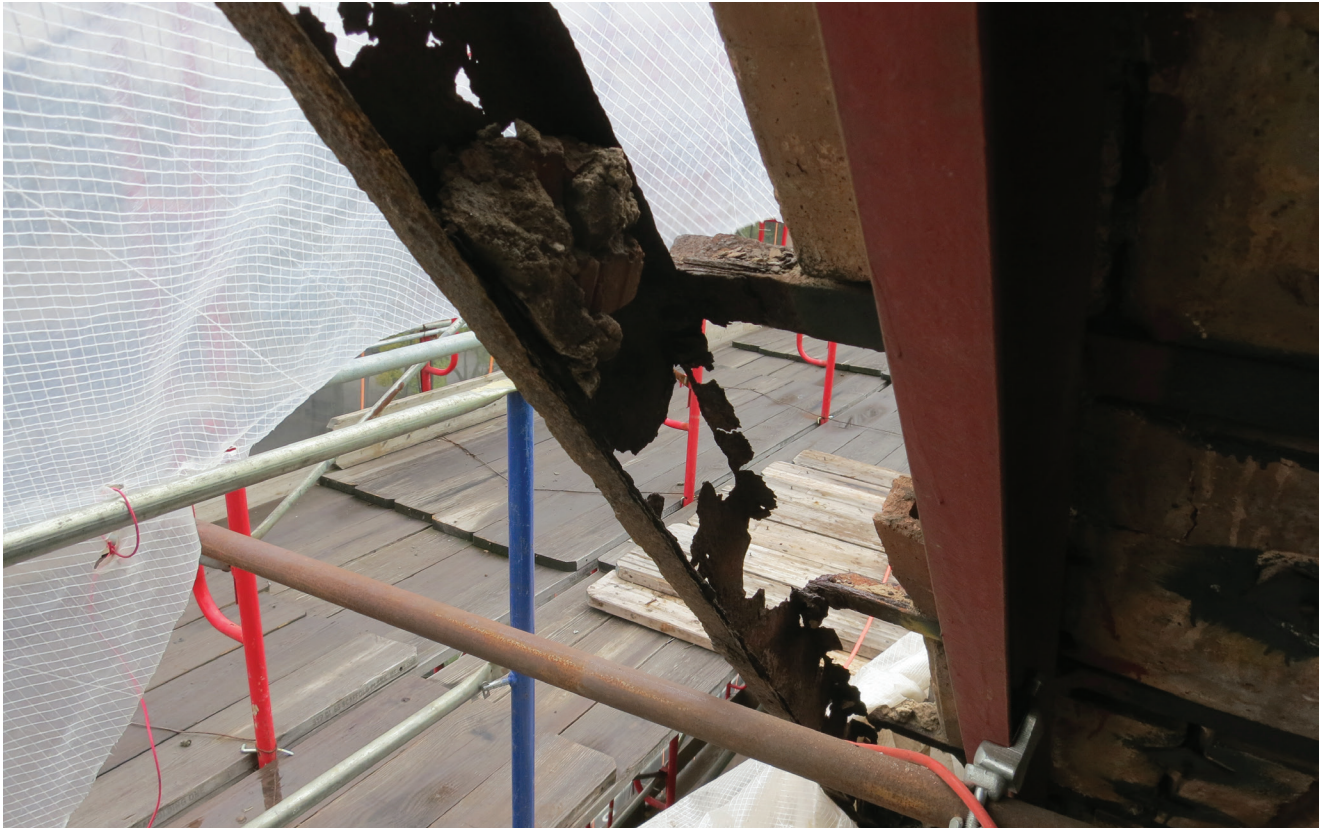
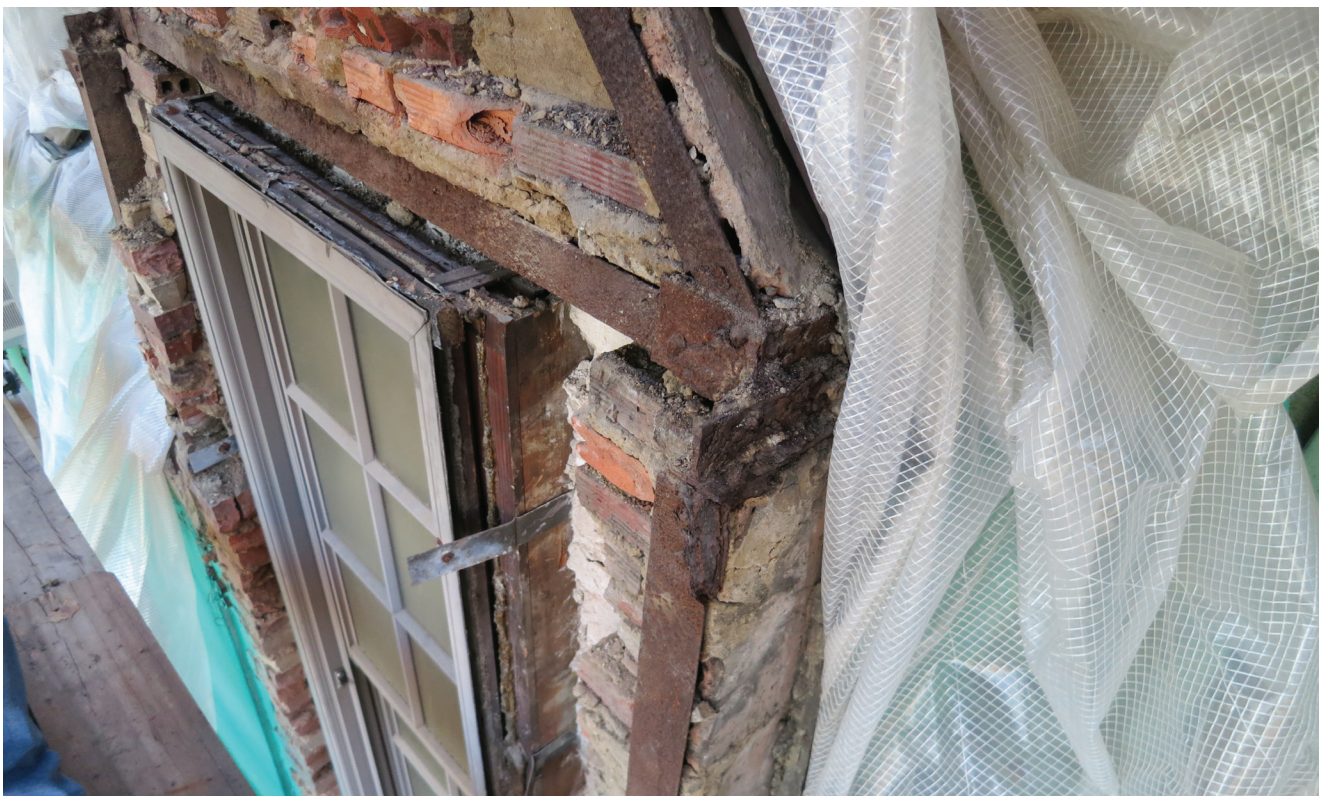
Fig. 6.1.38 (overleaf - top) & 6.1.39 (overleaf - bottom)

Extreme corrosion in the gables. Courtesy: Nelligan White Architects

4. The cast iron, wrought iron, and steel throughout the building exhibited a range of conditions. The cast iron columns and the very heavy built-up spandrel beams (with angle flanges thicker than 1") were in remarkably good condition – in some areas the original red-lead primer was still intact. Lighter steel sections – particularly the channels and angles used to frame the dormers were severely corroded to the point where they were almost non-existent. (See image) Wrought iron cramps fared better than light steel sections, however, even moderate corrosion where they were embedded in terracotta caused 'rust-jacking' failures.

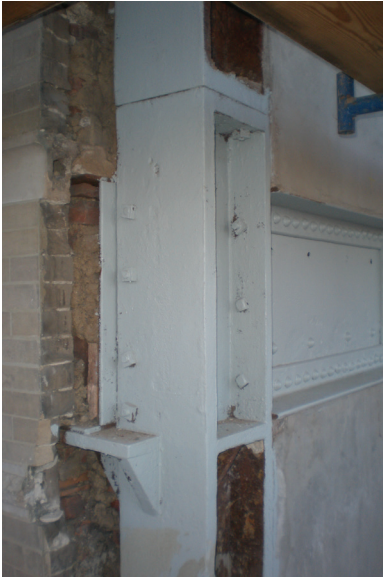
Fig. 6.1.40 & 6.1.41 (above - below)
Cast iron columns and the very heavy built-up spandrel beams were in remarkably good condition. Courtesy: Nelligan White Architects

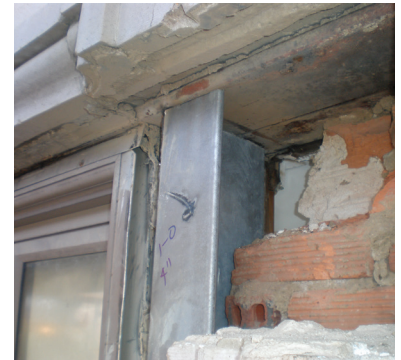
5. The most significant discovery was the extent to which the terracotta backup had contributed to the building's water related failures. Probes show the terracotta to be brick sized, and hollow with the cores oriented in the long direction of the tile rather than up-and-down like modern cored brick. Thus, any headers present the cores running perpendicular to the facade. Some of these were seen in probes and considered a source of water infiltration. When the face brick was removed, it was discovered that a header course was installed in the backup every 5th or 6th course, creating continuous lines of leaks through the building envelope.

Fig. 6.1.42
Probe observing terracotta backup. Courtesy:
Nelligan White Architects
