CASE STUDIES:

PS 277 X

Building ID	X277
School Level	PS
Address	519 Street Ann's Avenue Bronx, NY 10455
Cross Streets	E 147 th & 148 th Streets
NYC DOE District	07
SHPO Status	Eligible
SHPO ID	02PR3147
Flood Zone	Zone 6
FEMA Map	3604970083F
Architect	C.B.J. Snyder
Year Built	1897
Plan Form	Type-A
Style	English-Flemish Renaissance Revival
Internal Sq Ft	88,750
Classrooms	50
Stories	5 + Cellar
Structural System	Composite Masonry/Frame
Columns	Cast Iron
Beams	Steel
Floors	Round Terracotta Vaults
Roof	Copper, BUR (2011)
Cladding	Brick, Limestone, Terracotta
Backup	Brick, Terracotta

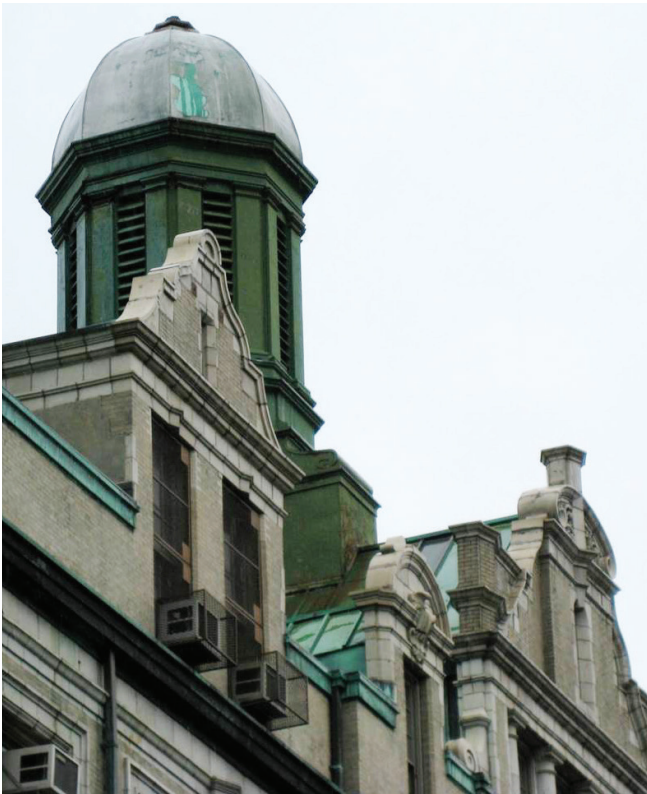
Fig. 6.1.1 - Before Rehabilitation

Years of moisture infiltration degraded the original mortar to an alarming extent, which contributed to the failure of all masonry elements. By 2008, emergency work was needed due to extensive leaking at the fifth floor and stairwells, leading to conditions of spalling and falling plaster that was deemed to be unsafe.

Fig. 6.1.1 & 6.1.2
A 'before and after' image of PS 277 X highlighting the rehabilitation at the spire and ornamental features at the front facade. The building's composite French Renaissance/Gothic style was intended to reference the great institutions of old world Europe. These inspirational structures stand in stark contrast to the dark, unsanitary schoolhouses common in New York City throughout the 19th century. Courtesy: Sylvia Hardy

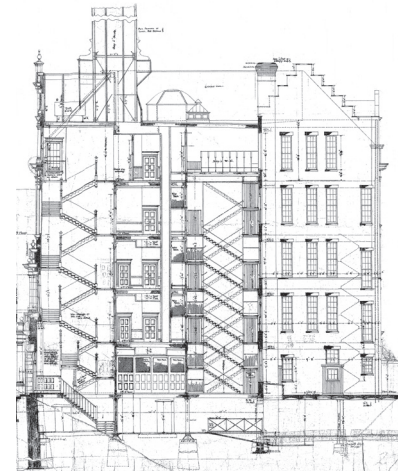
Fig. 6.1.3 (above)
Original 1895 building section, cut through the center of PS 277 X. The two central stair cores and the ventilation spire can be seen. Courtesy: SCA Alchemy

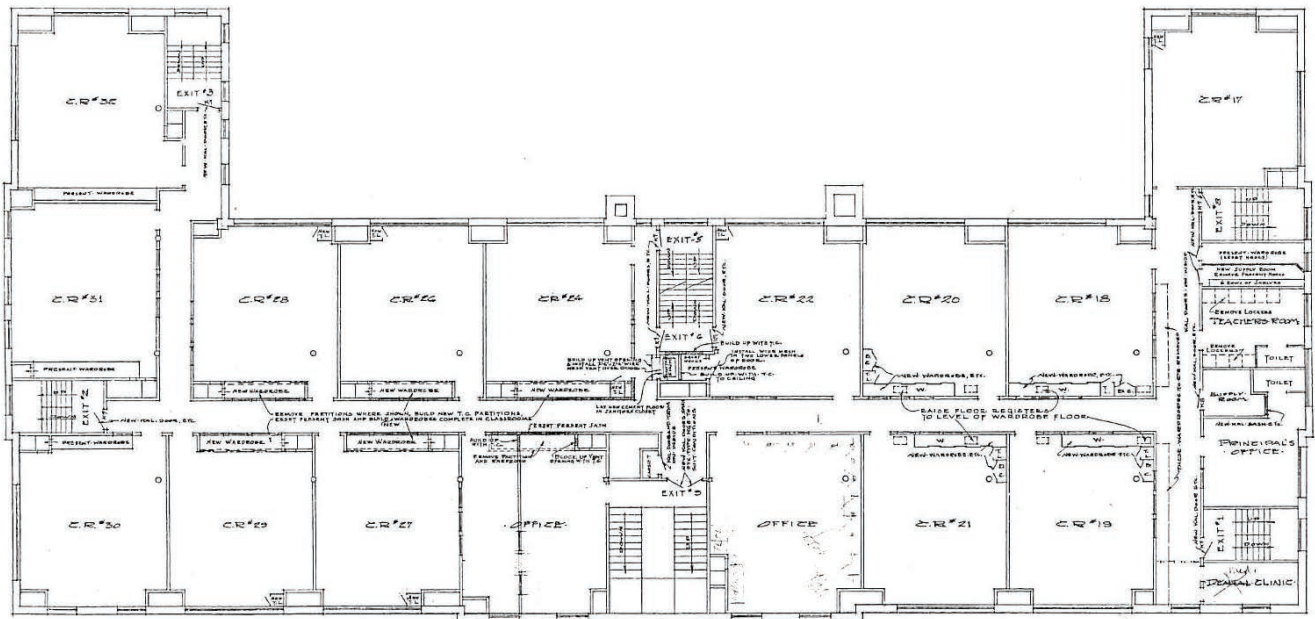
Fig. 6.1.4 (above)
Original 1895 third floor plan. Courtesy: SCA Alchemy

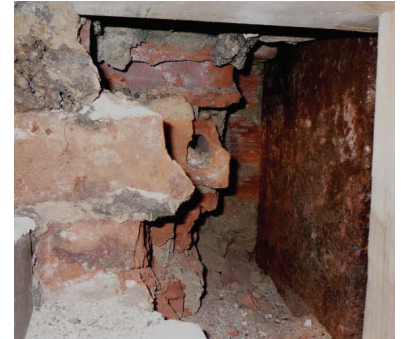
During the inspection of probes, material samples of face-brick, backup brick, and mortar were collected for laboratory testing of compressive strength, absorption and chemical composition. These tests indicated that the mortar used for the face-brick, backup and terracotta is Type-O mortar, a weak mortar with high lime-putty content, typically used at the turn of the 20th century, but is not currently recommended for climates that go through regular freeze-thaw cycles, like that of the Northeastern United States. Type-O mortar is more susceptible to wash-out than other mortars with lower lime putty content, and this mortar was mixed with a slightly high water-to-cement ratio. The laboratory tests also show that the mortar is completely carbonated, which results in the lowering of the pH around ferrous elements, including steel cramp anchors. This lower pH reduces the alkaline protection that cementitious materials provide to ferrous metals. The corrosion of steel and to a lesser extent cast and wrought iron elements has accelerated in the presence of water.

Testing of the face-brick and backup brick showed that both conformed to modern compressive and absorption standards. These tests indicated that it was not the masonry itself, but poor workmanship and hollow cores of the terracotta backup which provided conduits for moisture travel through the masonry. These deficiencies caused washout of the mortar and degradation of all masonry and steel elements as an effect.

Fig. 6.1.15 (above)
During the evaluation of exploratory probes, samples of backup masonry and mortar were extracted for testing. Courtesy: Nelligan White Architects

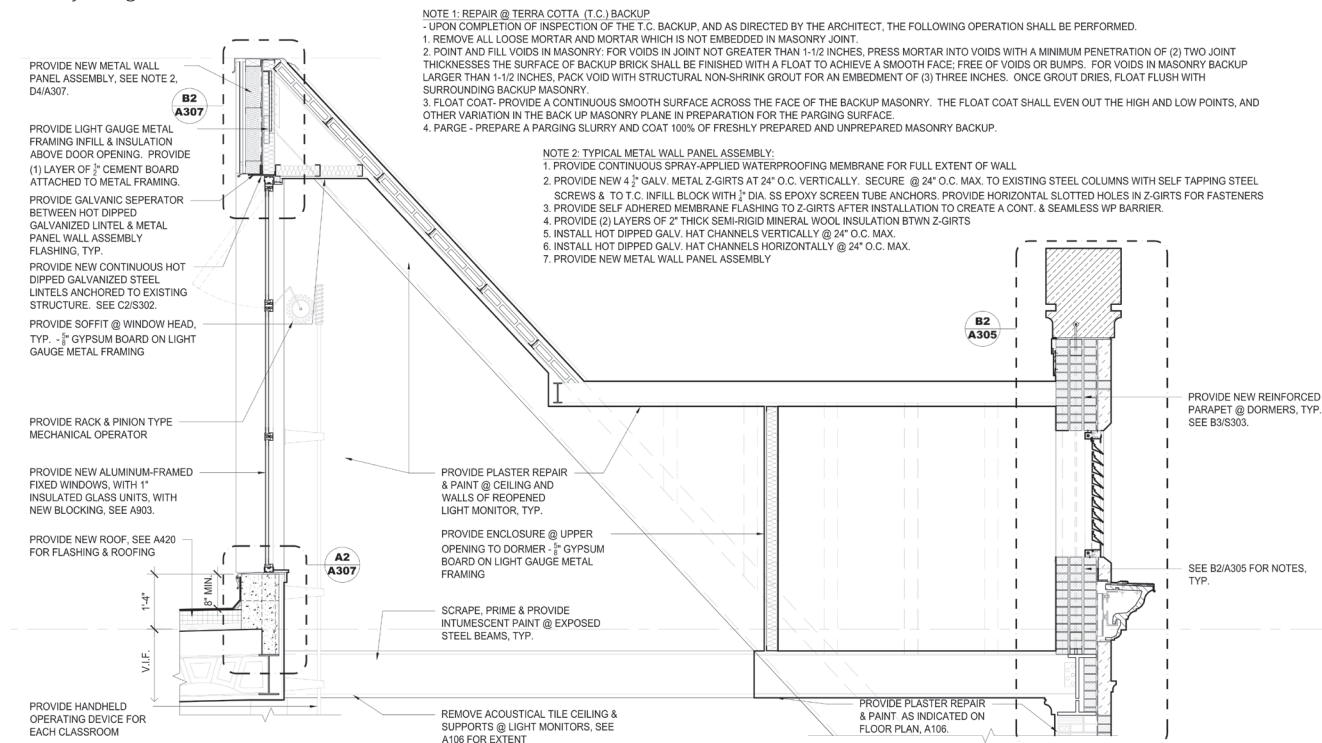
Fig. 6.1.18 (below)
Construction document showing the scope at the light monitors. Courtesy: Nelligan White Architects

- Remove all existing galvanized steel cladding & existing aluminum siding covering original light monitors.
- Removal galvanized cladding from back of mansards, existing light monitors, flashings and framing where damaged.

- Remove existing acoustic tile ceilings and light fixtures in rooms below the light monitors to allow for this work.
- Repair or replace the damaged metal panels and components of the ventilation tower.

- Expose, scrape, inspect, repair, paint, flash and fire protect existing exposed steel beams in 5th floor classrooms below light monitors, and replace if necessary.

- Install additional height to existing concrete curb to comply with roofing manufacturers requirements, install stainless steel curb flashing.
- Install new aluminum-framed tempered insulated glazed light monitor in original location.

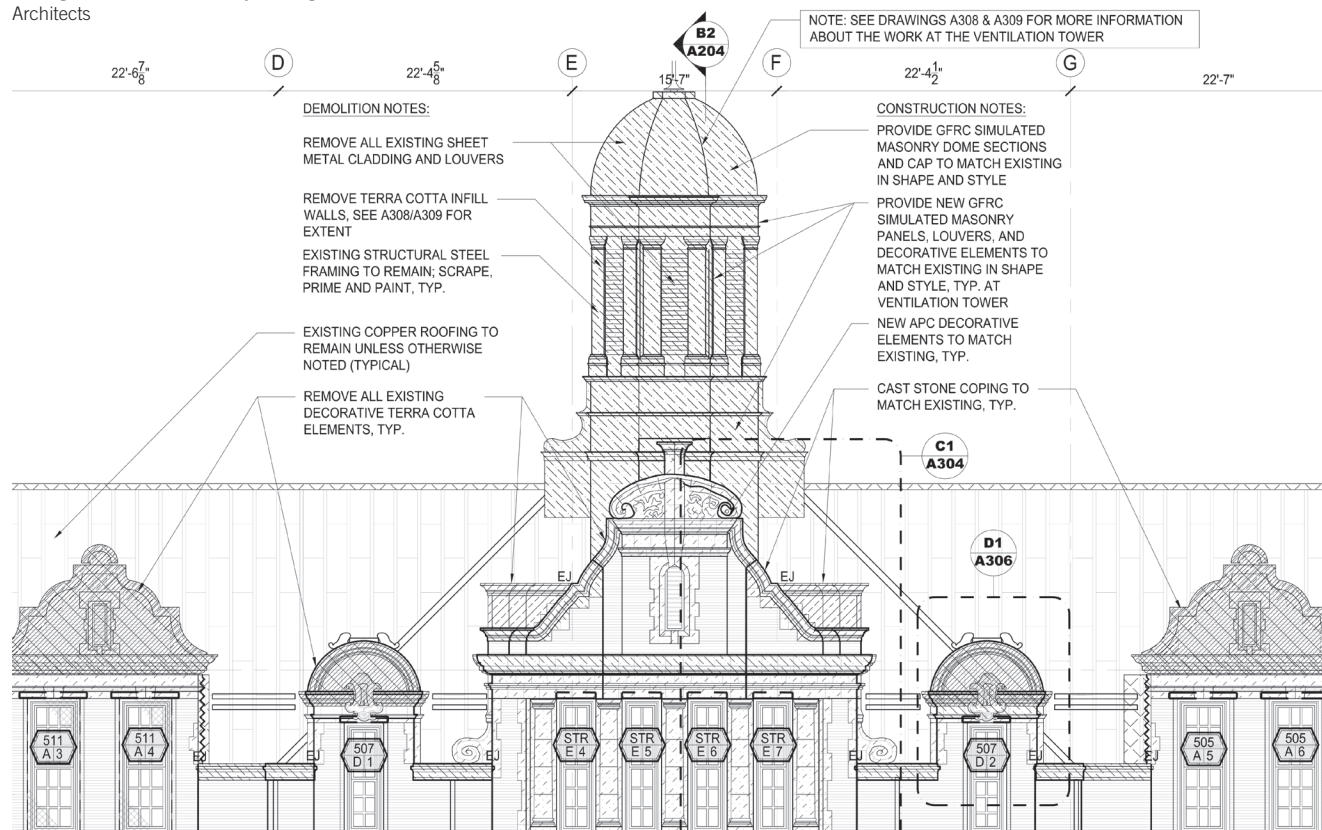
Recommendations & Design

Findings in the visual inspections, which were confirmed by the Assessment of Water Ingress Report, indicated that incomplete step flashing at the dormers was a major source of water infiltration through fifth floor classrooms and stairwells. Standing water and split seams were observed at gutters; and leaders were observed to be in poor condition. The copper mansard roof was found to be in fair condition, though the low-slope roof behind it was observed to be in very poor condition, by evidence of bubbling, cracking and missing ballast on the surface. Contact of dissimilar metals at several locations was noted, which may cause galvanic reactions and eventual deterioration as an effect. These findings prompted the following recommendations:

- Replace gutters and leaders around the mansard roof.
- Replace flashing at dormer returns and gable end walls.
- Provide for replacement of batten seam copper roofing as necessary to install flashing and gutters.

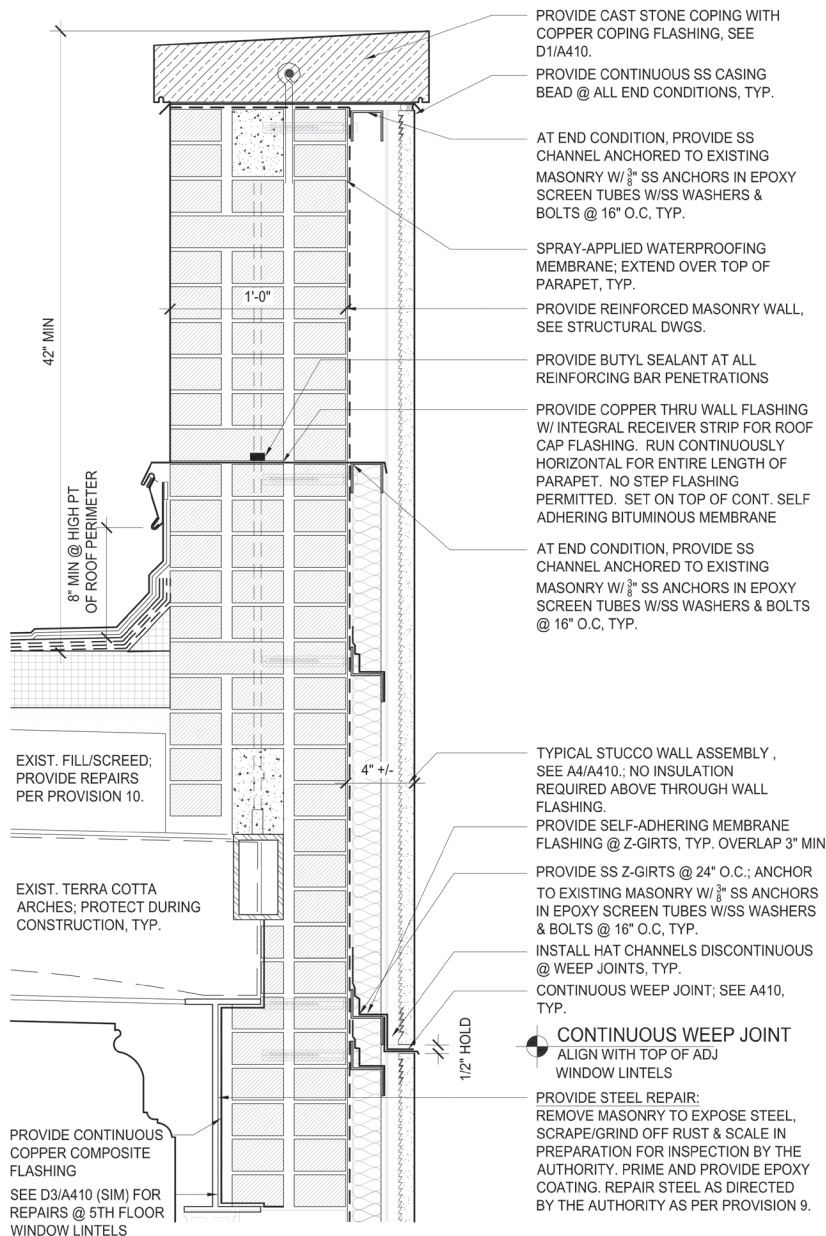
Fig. 6.1.30

Original design drawings, visual observations and probe investigations confirmed the absence of through-wall-flashing at the parapets. Probes along with the Assessment of Water Ingress Report confirmed that water passing through the back side of the parapet, was a significant source of damage at the top floor. These findings prompted the following recommendations:

Before rehabilitation, base flashing at parapet was not continuous. Courtesy: Nelligan White Architects

- Remove and replace existing masonry parapet with expansion joints, through-wall flashing, coping stones and scupper drains.

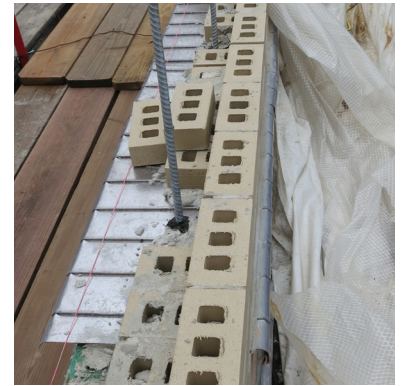
Fig. 6.1.28

Through-wall flashing during installation. Courtesy: Nelligan White Architects

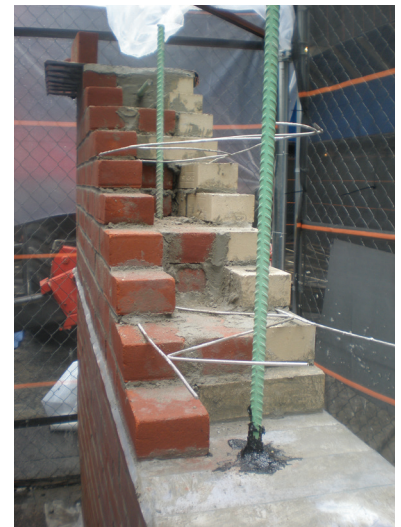
Fig. 6.1.29

Parapet mock-up with through wall flashing and truss reinforcing. Courtesy: Nelligan White Architects

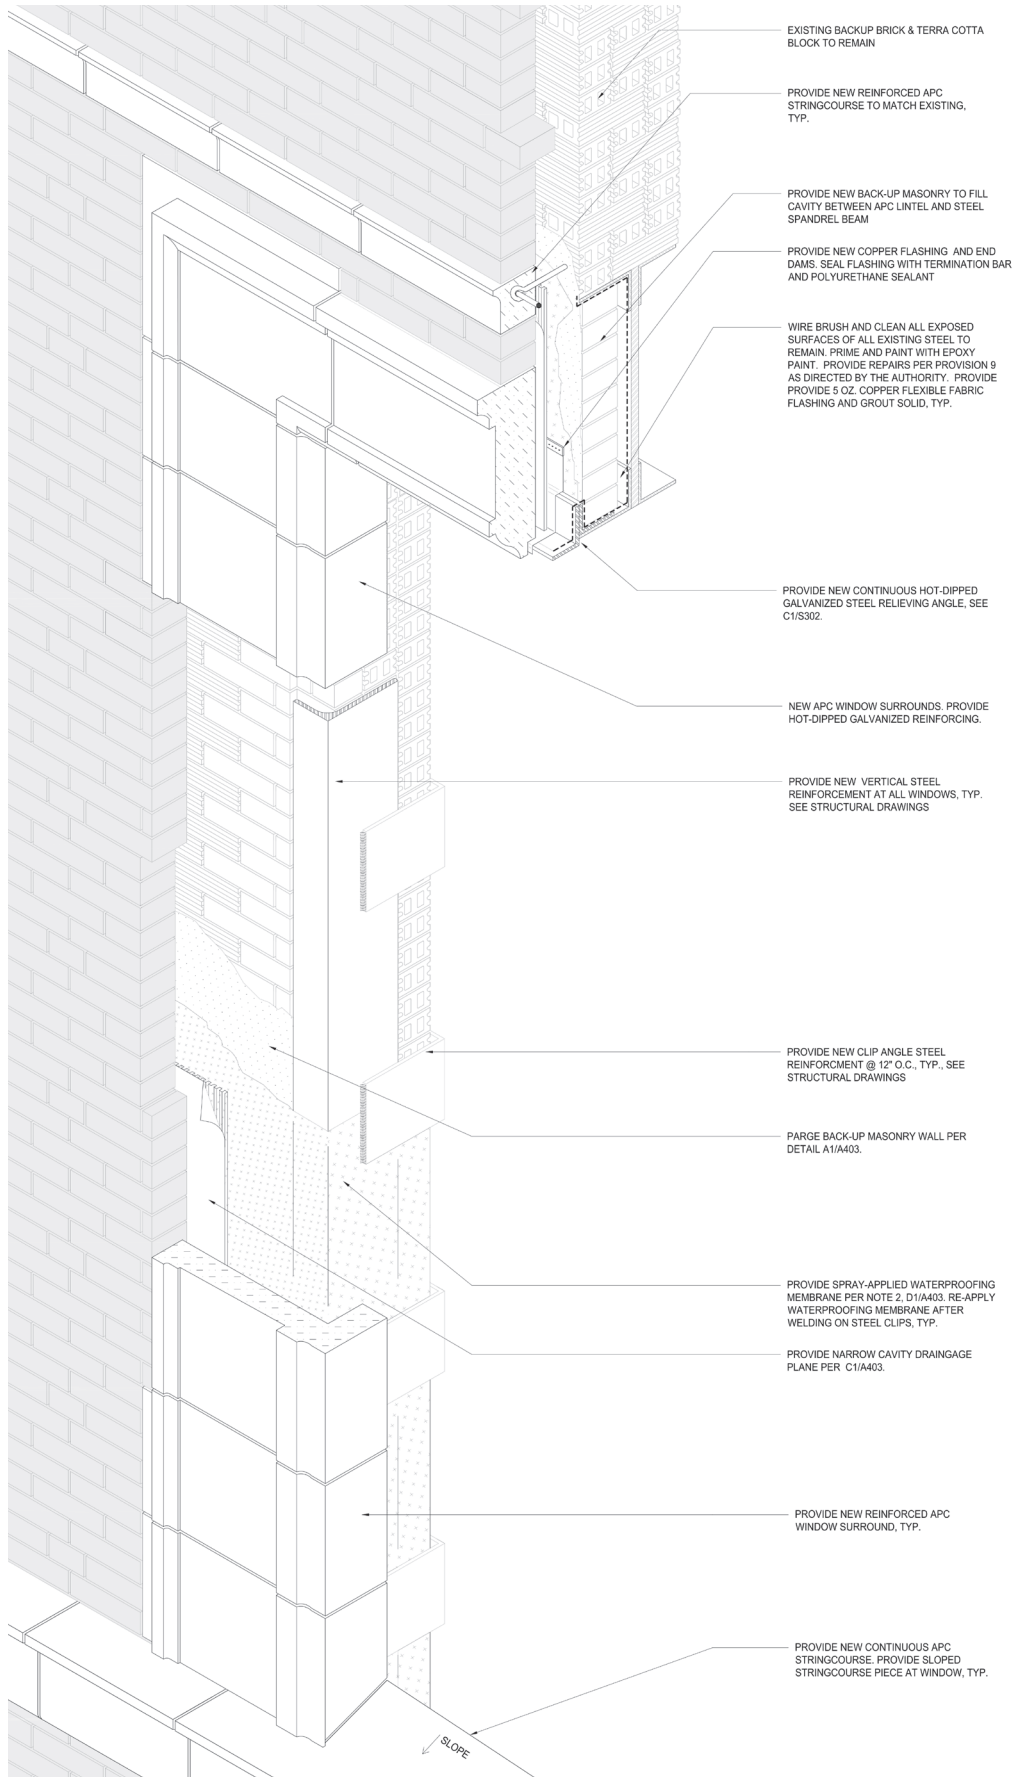
Fig. 6.1.30 (left)

Construction document, assemblies at the parapet and stucco wall. Courtesy: Nelligan White Architects

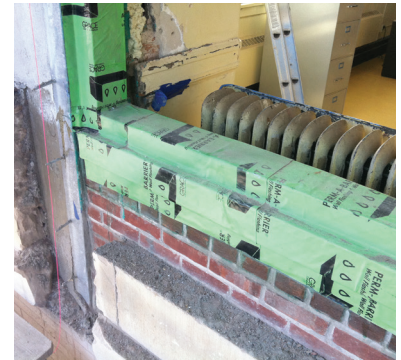
Fig. 6.1.31

It has been observed that many frame-constructed buildings from the late 19th century, and even some constructed as late the 1950s, had no provision for transferring wind loads from the building enclosure to the frame. At PS 277 X, the backup terracotta masonry simply sat within the frame of iron columns and steel spandrels and had stayed in place by gravity and good fortune. Where long spans of masonry occur between the floors, deflection under design wind loads would allow the masonry to crack. The short “knee-wall” below window openings provided almost no resistance to wind loads at the windows.

Cracking and flexing of the structure over the years has contributed to water penetration into the building. When face masonry is removed, the new building enclosure must be designed to accommodate code wind loads. At PS 277X this new structure has taken the form of “wind girts” – steel angles spanning vertically from spandrel to spandrel at each window opening and horizontal angles below each window sill. The intention of these girts is to reduce the span of each section of masonry to reduce its deflection under wind loads to a very small value, less than L/600, in order to prevent cracking of the masonry.

Peel and stick flashing and wind girts at the window opening during installation. Courtesy: Nelligan White Architects

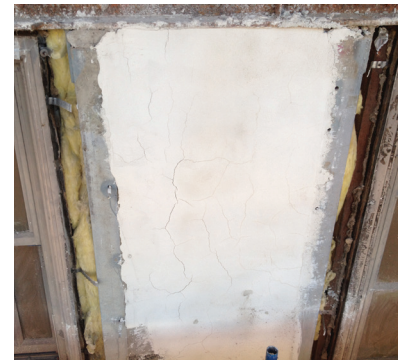
Fig. 6.1.32

Two wind girts at window openings during installation. Courtesy: Nelligan White Architects

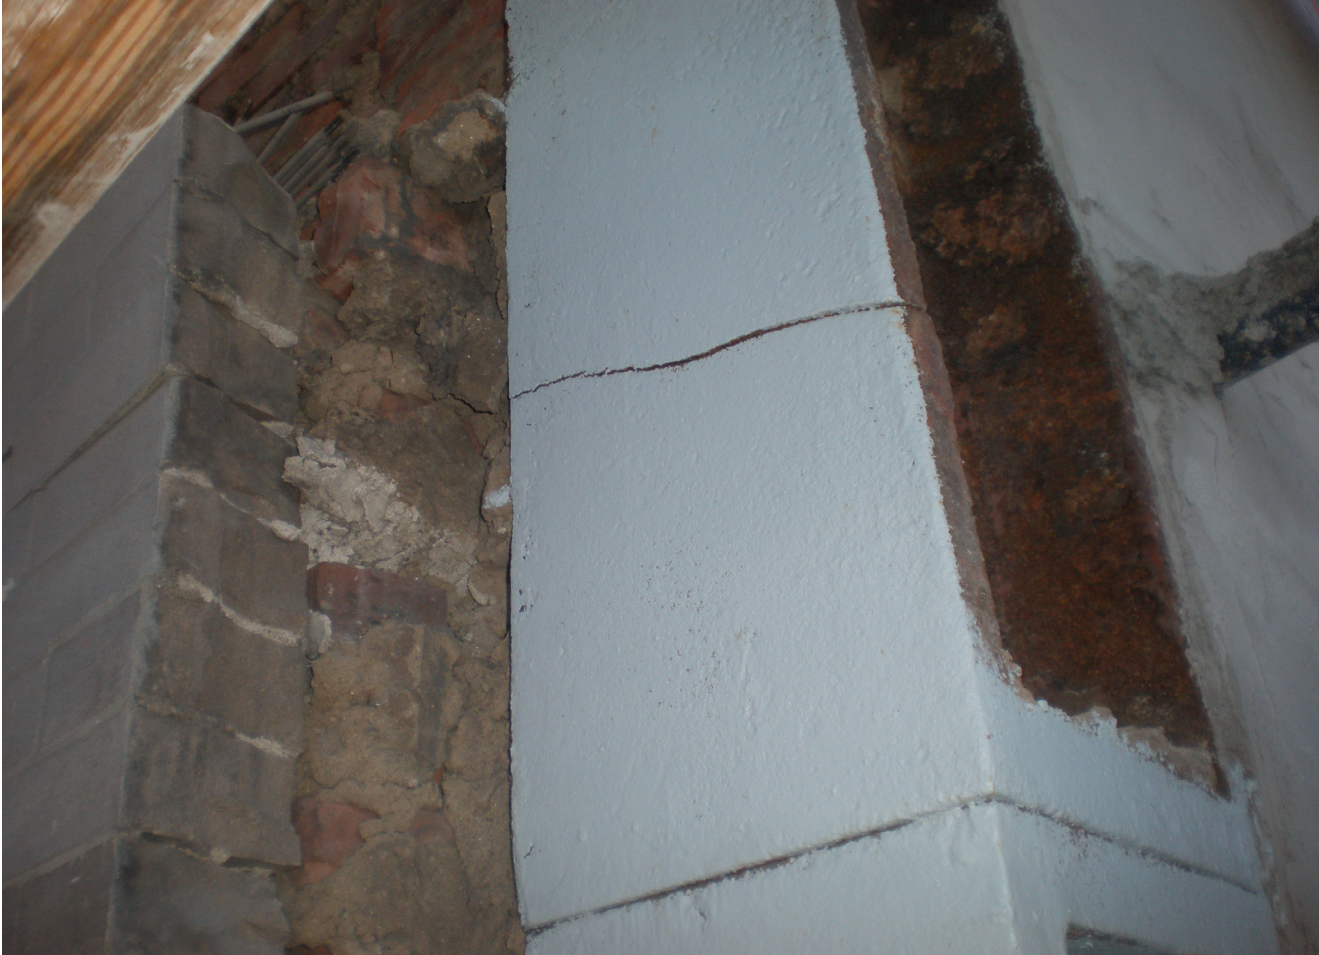
Fig 6.1.41

Fig. 6.1.40 & 6.1.41 (above - below)
Cast iron columns and the very heavy built-up spandrel beams were in remarkably good condition. Courtesy: Nelligan White Architects

4. The cast iron, wrought iron, and steel throughout the building exhibited a range of conditions. The cast iron columns and the very heavy built-up spandrel beams (with angle flanges thicker than 1") were in remarkably good condition – in some areas the original red-lead primer was still intact. Lighter steel sections – particularly the channels and angles used to frame the dormers were severely corroded to the point where they were almost non-existent. (See image) Wrought iron cramps fared better than light steel sections, however, even moderate corrosion where they were embedded in terracotta caused 'rust-jacking' failures.

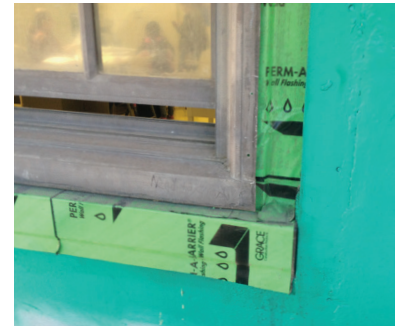
Fig. 6.1.43
Aluminum window reinstalled. Courtesy:
Nelligan White Architects

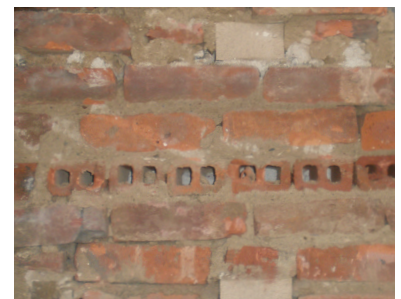
Fig. 6.1.44
Existing backup prior to spray application.
Courtesy: Nelligan White Architects
